St. Brannock's Church, Braunton

Spire Repairs - 2002

Repairs and cleaning following an arson fire in July 2003

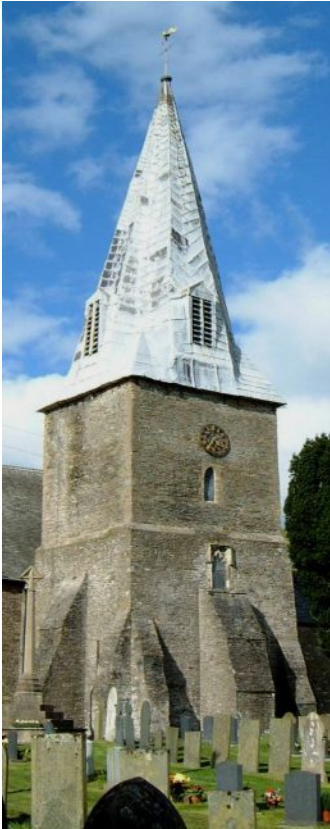
Before

Following a close inspection of the lead from a rope and abseil harness it was clear that the cast lead panels were reaching the end of their life. It was also clear following initial inspections that the structure required fundamental repairs.

The oak timber frame of the spire is immensely complex, the result of many internal changes, repairs, shoring and additional bracing in its 800 year history. The structure itself had skewed having suffered most of its historic decay on the most weathered west face.

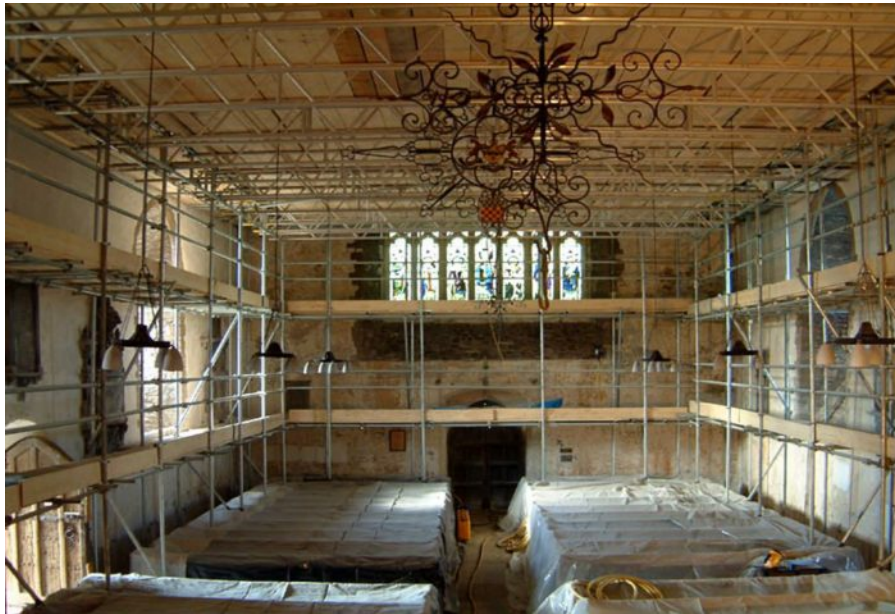
During restoration.

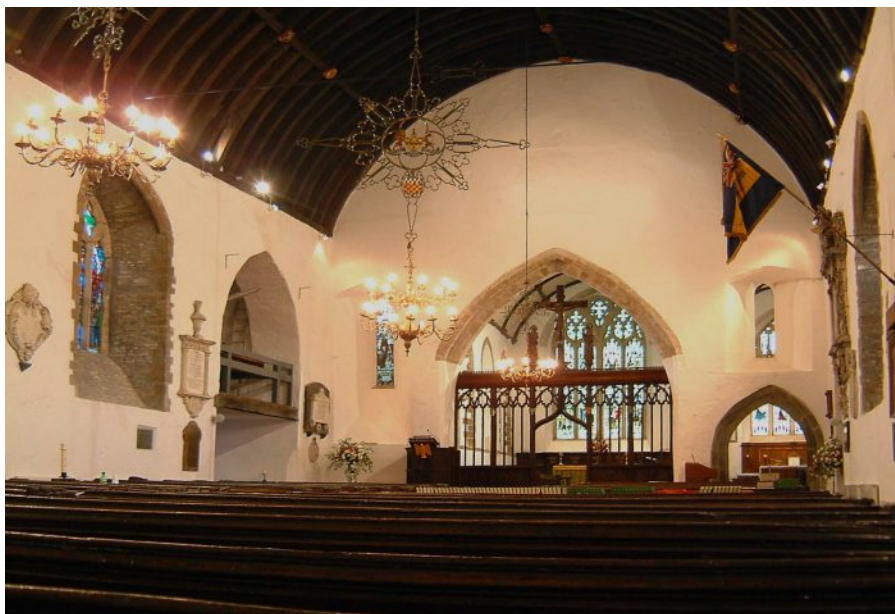
The fully repaired church.
