High Bickington Church

JONATHAN RHIND . ARCHITECTS

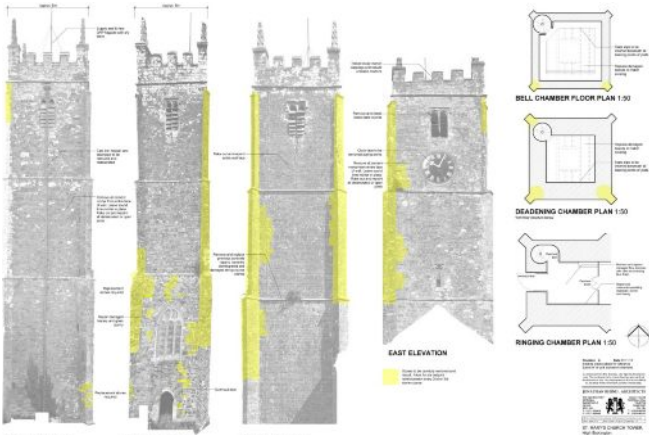
The church tower was initially scaffolded in 2010 to allow assessment of the buttresses, but was not eligible for English Heritage grant aid. The condition of the tower, with stones falling off the buttresses, deteriorated over the bad winters of 2012 and 2013..

On close inspection it was found that the external facing stones were not properly bonded to the rubble core and the separation was worse on the exposed buttresses. Previous campaigns of repair from the 1950's onwards had used cement which had exacerbated the problem.

The repair approach, arrived at with Structural Engineer Paul Carpenter, was to put thin stainless steel ties within the stone bed joints around three sides of the tower and buttresses, and fix back into the core, rebuild the buttresses and repair or replace damaged stonework to the wall faces.
