projects / conservation

THE MILL HOUSE

Grade II listed sixteenth century cottage, Mill House, is perched on the rocks of the wild North Devon coast.

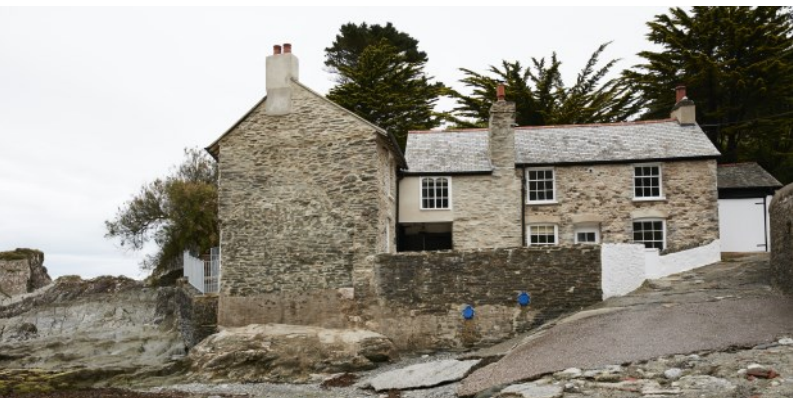
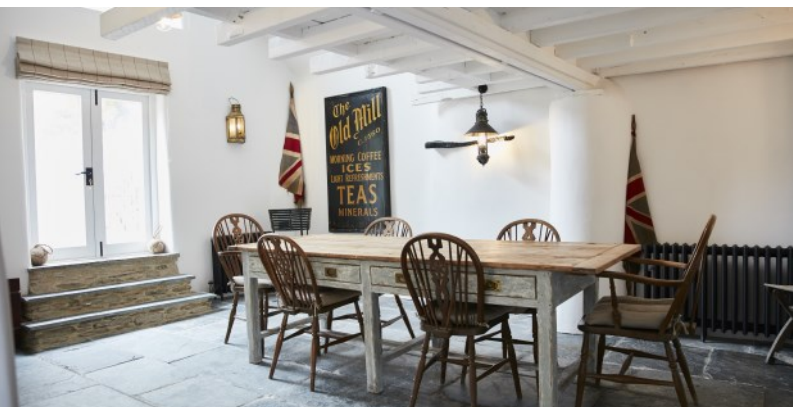
Top: Heavily eroded stonework before and after repointing in lime mortar

The property needed complete repair and refurbishment, including, upgrading the failed internal tanking system; comprehensive lime work to the external stonework to help protect the house from future sea water damage; reslating the roofs with a mix of reused and reclaimed natural slate; repair and repointing of walls and chimney; and an unusual new hydraulically operated drawbridge to give access to the sea wall terrace. The drawbridge, when raised, also provides protection to the glazed doors during storms.

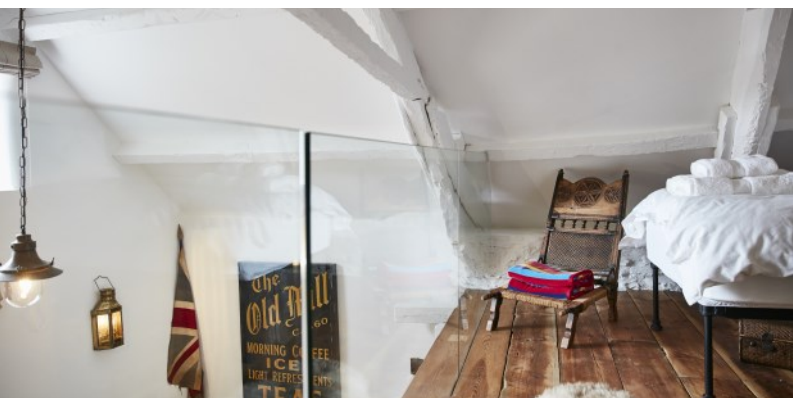
Centre left: Kitchen ceiling / mezzanine floor with rotted floor and saturated walls
