St. Brannock's Church, Braunton

Spire Repairs - 2002

Repairs and cleaning following an arson fire in July 2003

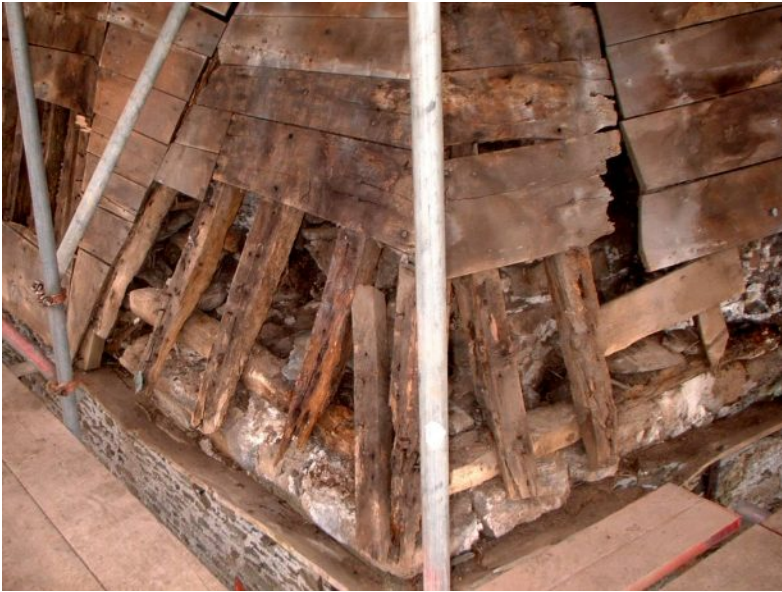
Following a close inspection of the lead from a rope and abseil harness it was clear that the cast lead panels were reaching the end of their life. It was also clear following initial inspections that the structure required fundamental repairs.

The oak timber frame of the spire is immensely complex, the result of many internal changes, repairs, shoring and additional bracing in its 800 year history. The structure itself had skewed having suffered most of its historic decay on the most weathered west face.

Due to the complex nature of the structure we commissioned an accurate three dimensional survey of the structure that could digitally model the timber structure. At the same time the archaeological survey recorded the size, location, condition and joint details of each timber element. This helped identify the age of each timber and the historically important sections of timber for analysing the impact of repair proposals.

As a result, very little historic fabric needed to be replaced and previous phases of repair remain undisturbed whether they contribute to the structural strength of the spire or not.

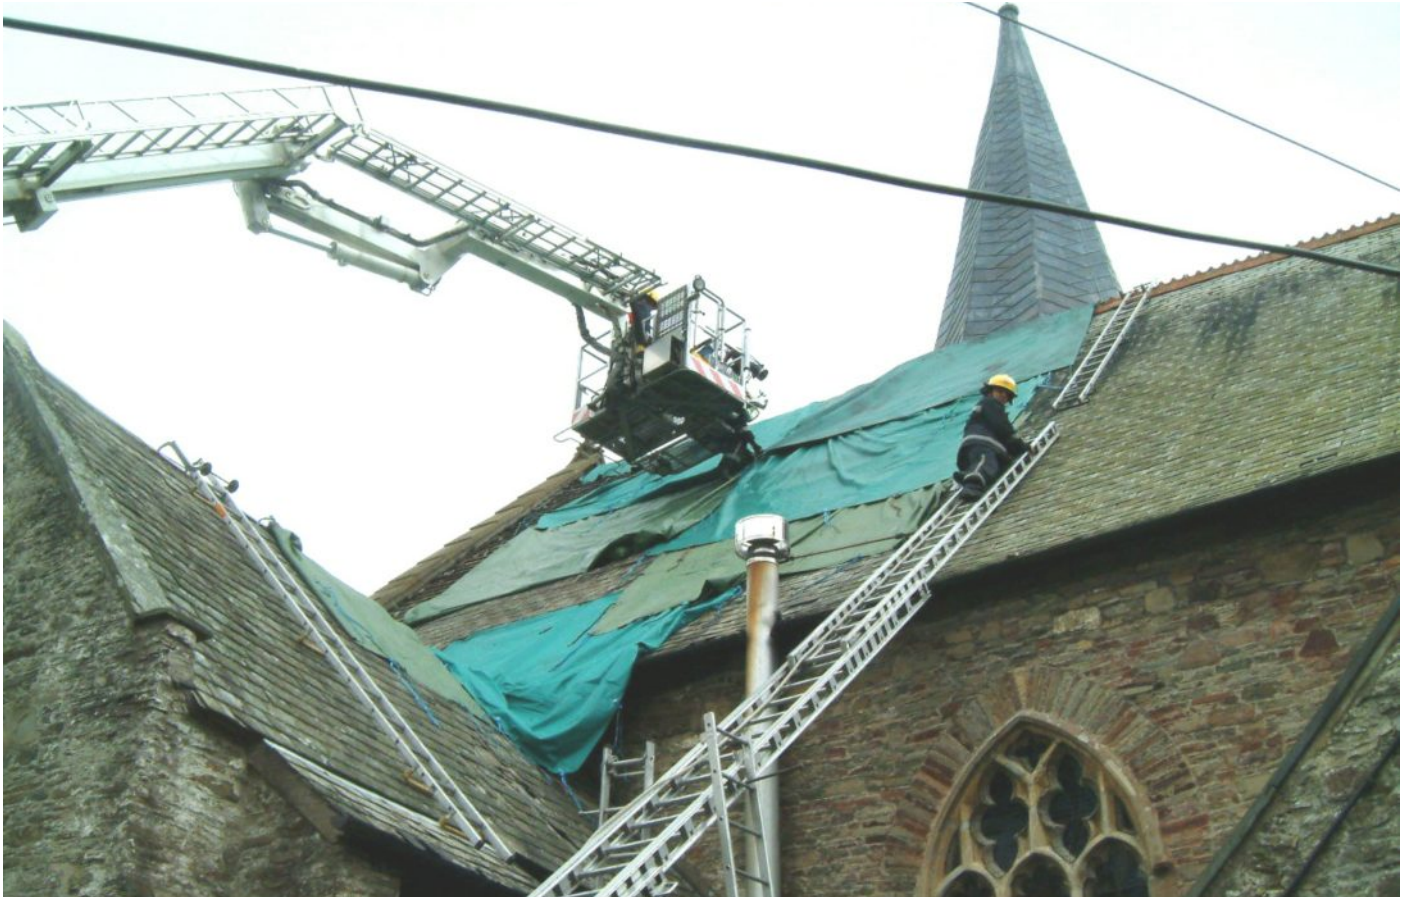
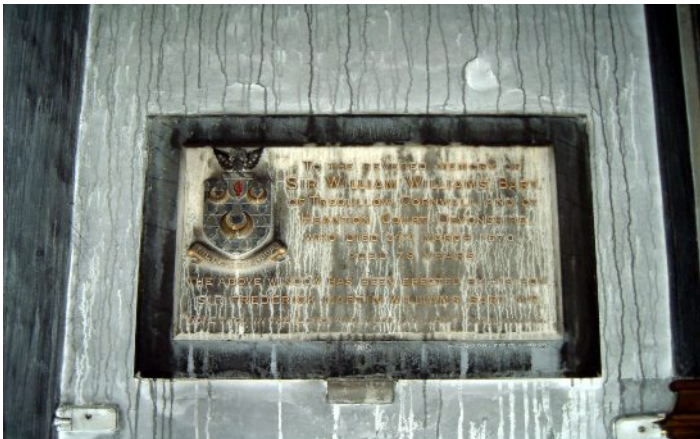
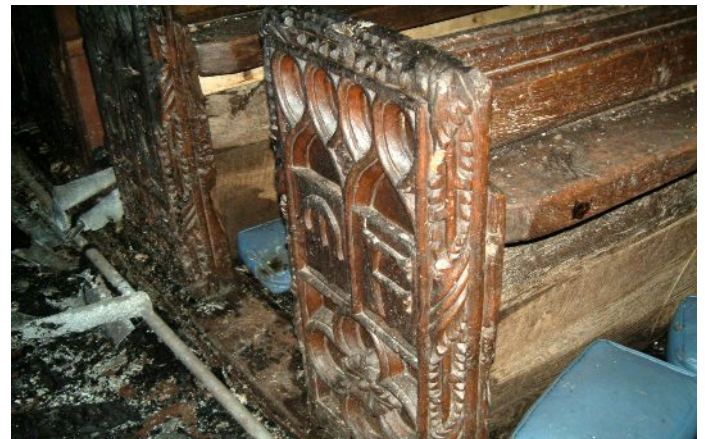
A fire started below the organ loft in the north transept and quickly spread into the roof filling the entire church with smoke. The resulting fire, smoke and water damage was comprehensively assessed by a team of specialists and conservators, commissioned and coordinated by the practice.

This included timber dating of the nave roof structure funded separately by English Heritage. As the church was closed for repairs and cleaning, the church took the opportunity to re-order the interior of the nave to bring the focus of the worship closer to the congregation. This could involve the relocation of some of the pews in the nave and included upgrading the heating, lighting, sound system, fire protection and security of the building. The practice introduced localised sprinkler systems to areas of the interior that were most at risk from fire in the future.
