High Bickington Church

JONATHAN RHIND . ARCHITECTS

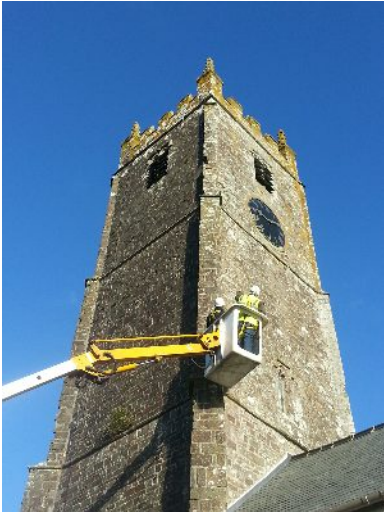
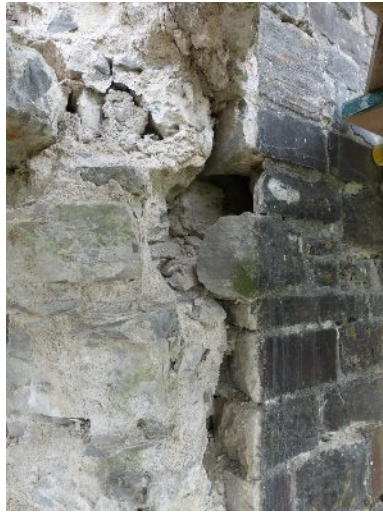
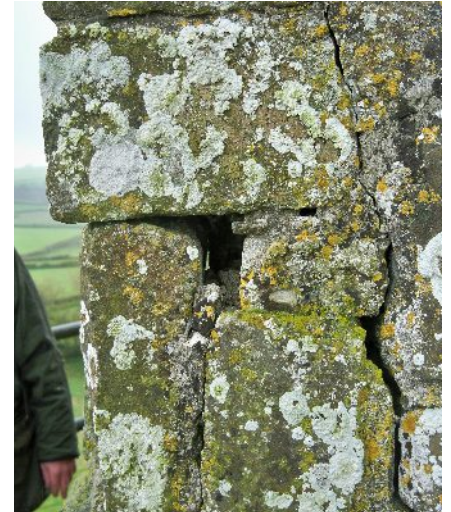
The church tower was initially scaffolded in 2010 to allow assessment of the buttresses, but was not eligible for English Heritage grant aid. The condition of the tower, with stones falling off the buttresses, deteriorated over the bad winters of 2012 and 2013..

On close inspection it was found that the external facing stones were not properly bonded to the rubble core and the separation was worse on the exposed buttresses. Previous campaigns of repair from the 1950's onwards had used cement which had exacerbated the problem.

The repair approach, arrived at with Structural Engineer Paul Carpenter, was to put thin stainless steel ties within the stone bed joints around three sides of the tower and buttresses, and fix back into the core, rebuild the buttresses and repair or replace damaged stonework to the wall faces.

The work was carried out by skilled stonemasons, Carrek Ltd. of Wells from July 2014 and completed and scaffold removed in early 2015.
