# The Gildhouse, Poundstock, N. Cornwall

This 15th Century Gildhouse in North Cornwall was repaired and reordered during 2007 to enable its use as a Church Hall with the assistance of the Heritage Lottery Fund. The building is a typical, early north Cornish construction with cob upper walls, stone ground floor and timber framed cruck roof.

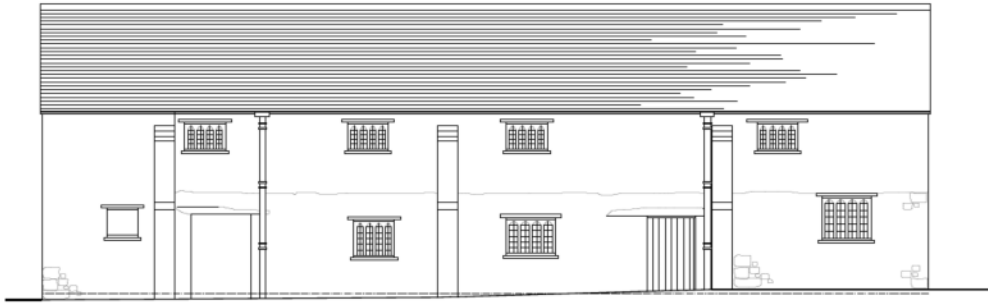
*West Elevation*

*Surface repairs to cob held with oak pegs and deeper repairs to walls.*

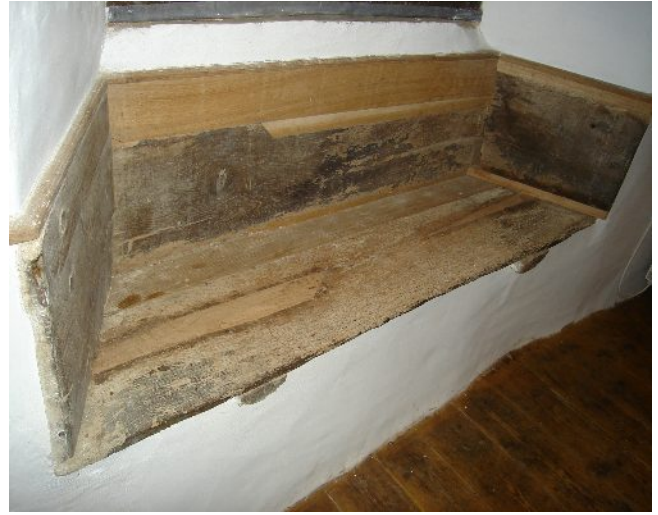
*Window seat - repaired.*

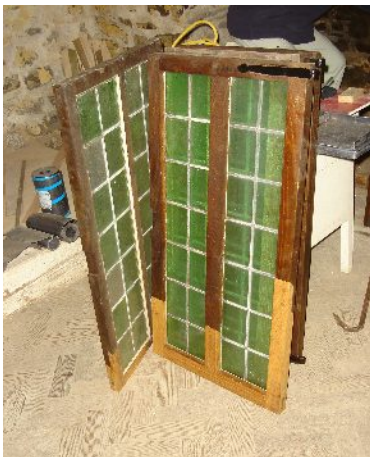
*Scarfed timber repairs to windows.*

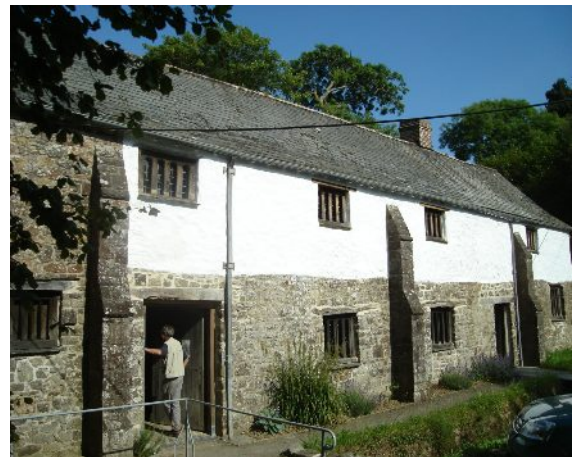
*Completed West Elevation.*
